**Flood Control Project Maintenance
Levee Inspections**

Fall 2015 Levee Maintenance Deficiency Summary Report

Sacramento River Basin

Sutter Maintenance Yard Maintenance Area 0001

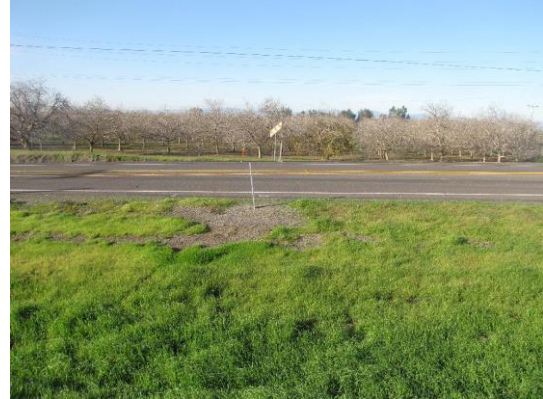
Photo 1 of 3 : UCIP_FA_2015_6505.jpg

Action/Comments					
Inspector Comments: FS_ID:44719 DS_ID:16448 EP_NO: 14424 FS_HLM: 16.913 Repair Type: Non-Urgent Crossing Status: Found UCIP Comments: 4/21/2015 Same as last inspection.11/3/2014 (DWR-Olivia) Need to contact owner to determine when markers will be placed. 6/23/2014 Same as last inspection.12/17/2013 Same as last inspection7/22/2013 Same as last inspection..11/2012 Utility warning sign damaged. Olivia (UCIP team) is coordinating with PG&E to determine more info on crossing. 12/2012 Waiting for information regarding crossing from PG&E. Regarding damage warning sign-- PG&E has initiated a project to replace pipeline crossing sign and utility markers, as required by DOT codes/regulations. FIELD_STRUCT_DESC: 12-inch gas pipeline through levee, 30-inches below crown. This 12-inch replacement pipe was installed by horizontally directionally drilling under the State HWY. Crossing is cathodically protected against external corrosion. (Permit No. 14424-1988, PG&E) Emergency contact Monte Penland, Gas Maintenance Supervisor, 15871 Central Street, Meridian, CA 95957; Office No. 530-634-6520 or Mobile No. 530-356-7396. Utility crossing coordinates are approximate. This pipe is under pressure and cathodic protection (CP) readings are taken on a regular schedule. FS Date: 04/22/2015

View of utility marker located on landward side across hwy.

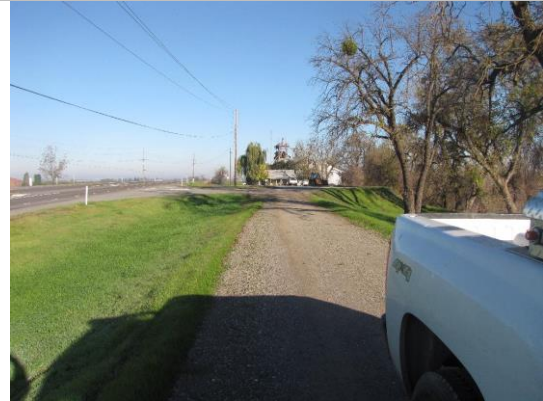
Photo 2 of 3 : UCIP_FA_2015_6506.jpg

Action/Comments					
Inspector Comments: FS_ID:44719 DS_ID:16448 EP_NO: 14424 FS_HLM: 16.913 Repair Type: Non-Urgent Crossing Status: Found UCIP Comments: 4/21/2015 Same as last inspection.11/3/2014 (DWR-Olivia) Need to contact owner to determine when markers will be placed. 6/23/2014 Same as last inspection.12/17/2013 Same as last inspection.7/22/2013 Same as last inspection..11/2012 Utility warning sign damaged. Olivia (UCIP team) is coordinating with PG&E to determine more info on crossing. 12/2012 Waiting for information regarding crossing from PG&E. Regarding damage warning sign-- PG&E has initiated a project to replace pipeline crossing sign and utility markers, as required by DOT codes/regulations. FIELD_STRUCT_DESC: 12-inch gas pipeline through levee, 30-inches below crown. This 12-inch replacement pipe was installed by horizontally directionally drilling under the State HWY. Crossing is cathodically protected against external corrosion. (Permit No. 14424-1988, PG&E) Emergency contact Monte Penland, Gas Maintenance Supervisor, 15871 Central Street, Meridian, CA 95957; Office No. 530-634-6520 or Mobile No. 530-356-7396. Utility crossing coordinates are approximate. This pipe is under pressure and cathodic protection (CP) readings are taken on a regular schedule. FS Date: 04/22/2015

View just upstream of utility crossing.

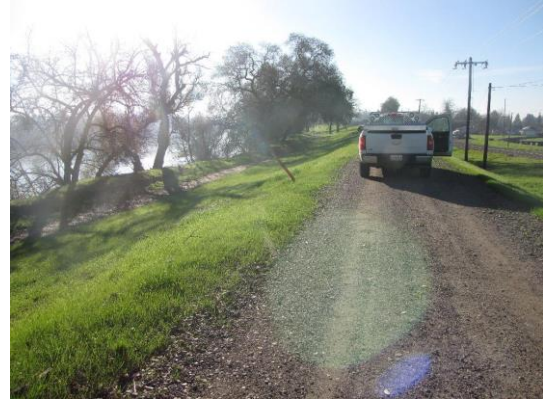
Photo 3 of 3 : UCIP_FA_2015_6507.jpg

Action/Comments					
Inspector Comments: FS_ID:44719					
DS_ID:16448					
EP_NO: 14424					
FS_HLM: 16.913					
Repair Type: Non-Urgent					
Crossing Status: Found					
UCIP Comments: 4/21/2015 Same as last inspection.11/3/2014 (DWR-Olivia) Need to contact owner to determine when markers will be placed. 6/23/2014 Same as last inspection.12/17/2013 Same as last inspection7/22/2013 Same as last inspection..11/2012 Utility warning sign damaged. Olivia (UCIP team) is coordinating with PG&E to determine more info on crossing. 12/2012 Waiting for information regarding crossing from PG&E. Regarding damage warning sign-- PG&E has initiated a project to replace pipeline crossing sign and utility markers, as required by DOT codes/regulations.					
FIELD_STRUCT_DESC: 12-inch gas pipeline through levee, 30-inches below crown. This 12-inch replacement pipe was installed by horizontally directionally drilling under the State HWY. Crossing is cathodically protected against external corrosion. (Permit No. 14424-1988, PG&E) Emergency contact Monte Penland, Gas Maintenance Supervisor, 15871 Central Street, Meridian, CA 95957; Office No. 530-634-6520 or Mobile No. 530-356-7396. Utility crossing coordinates are approximate. This pipe is under pressure and cathodic protection (CP) readings are taken on a regular schedule.

View of levee looking downstream at crossing.
